# **Evaluation of Stripped and Replated Component Termination Finishes**

**Guhan Subbarayan, Robert Kinyanjui**

**Sanmina-SCI**

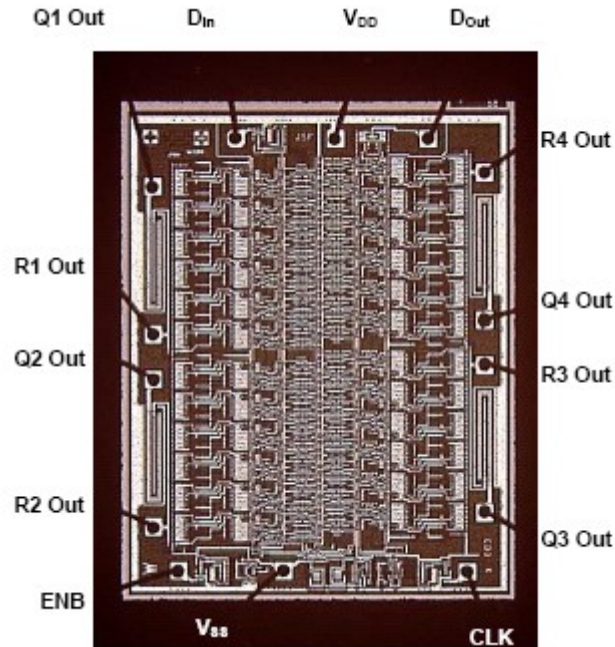
Figure 1: Optical Image of Die for Part#5

The parts were de-encapsulated with fuming nitric acid to expose the die for inspection. The inspection was performed with high power optical microscopy and die marking. No anomalies were observed. [Figure 1](#), shows an optical image of die (Part#5) with no anomalies.

Ball bonds were intact and well placed on bond pads. Bond pads were free of contamination with no signs of corrosion present. Die fabrication process utilized a single level of aluminum metallization passivated by glassivation layer(s). No glassivation or metallization anomalies were evident.

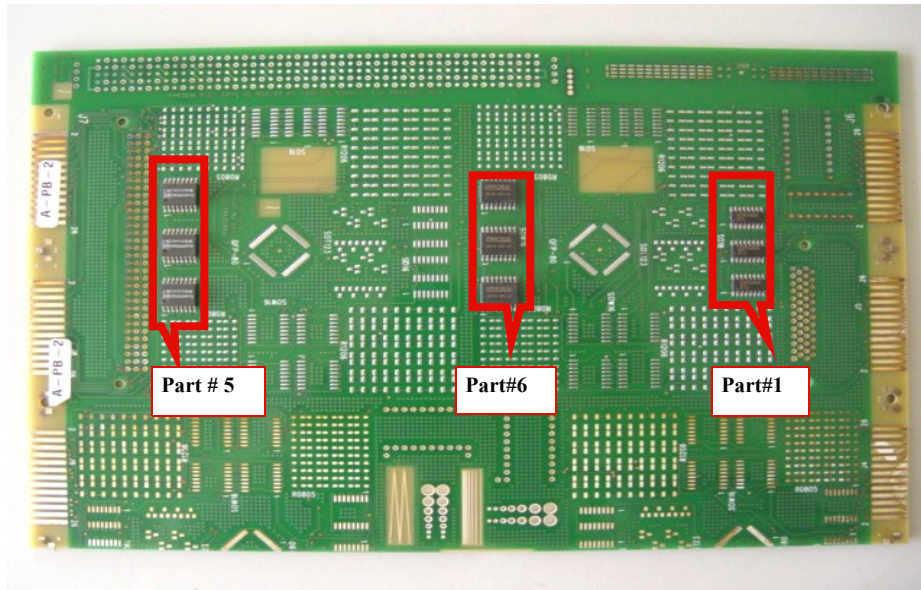
Figure 2: Sn-Pb components on PCB

Components with Sn-Pb finish (Part # 1, 5, 6 from Table 1) were assembled on the PCB test vehicle, as shown in Figure 2. Components with Pb-free finish (Part # 2, 3, 4, 7, 8, 9 from Table 1) were assembled on the PCB test vehicle as shown in Figure 3. A sample size of three components were assembled for each part number type. The PCB dimensions were 6.5 inches by 10 inches. It was 0.093 inches thick with 8 layers. Three PCB surface finishes, namely ImAg, OSP and ENIG were evaluated in this experiment.

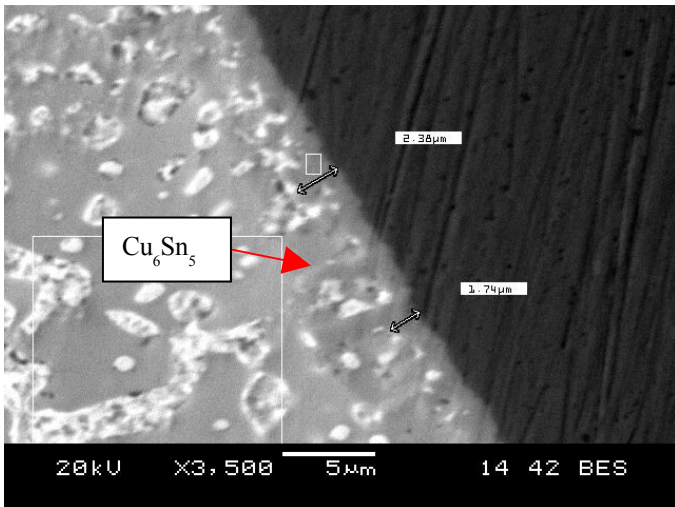
**Figure 4:** A representative SEM view of part#1 (Converted from 100% Sn to Sn-Pb termination finish) solder joint showing well defined IMC at as assembled condition

The IMC for all the part numbers cross-sectioned (Part # 1, 2, 3, 4) showed normal appearance, acceptable thickness and was well defined along the board and at the component interface. Solder wetting, fillet and voiding were within the acceptable limits as per IPC 610D standards. There were also no cracks found in all the samples investigated. The microstructure of the part converted from matte tin to Sn-Pb termination finish (part#1) was consistent with that of a typical Sn-Pb solder joint [5, 6], as shown in [Figure 4](#). The IMC composition was mainly  $\text{Cu}_6\text{Sn}_5$  phase. Thermal aging produced an increase in growth of the IMC layer and the  $\text{Cu}_3\text{Sn}$  layer became apparent, as shown in [Figure 5](#).

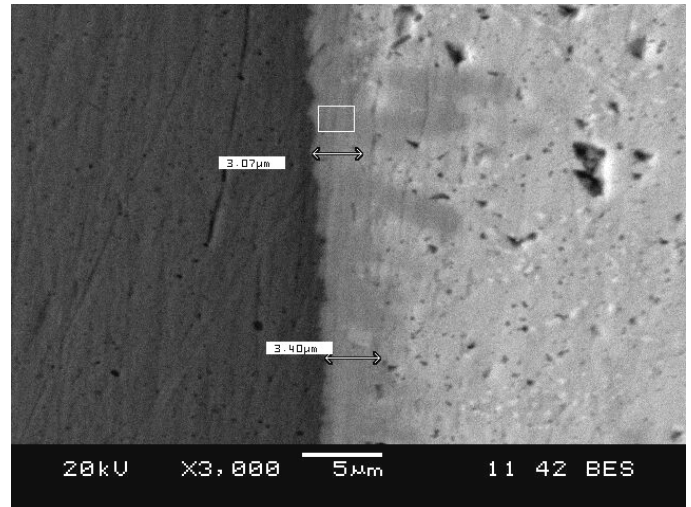
**Figure 6:** A representative view of part# 2 with Pb-free termination finish showing scallop shaped IMC at as assembled condition.

The microstructures of converted Pb-free components (Part#2, 3) were similar in appearance as to that of original Pb-free component (Part#4) but quite different from Sn-Pb components. The IMC at the component interface had a scalloped shape as shown in [Figure 6](#). Thermal aging produced increased growth rate of IMC for all Pb-free components at the component interface but not significantly at board interface.

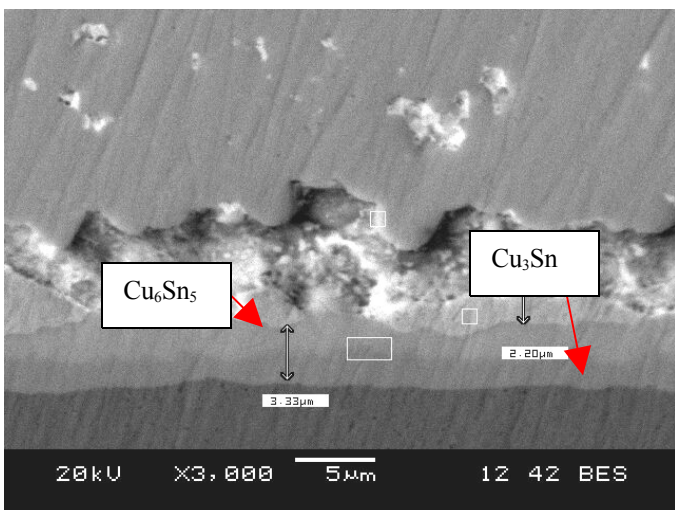
**Figure 5:** A representative SEM view of part# 1 following thermal aging (150 °C for 10 days) showing increased IMC thickness and appearance of Cu<sub>3</sub>Sn layer.

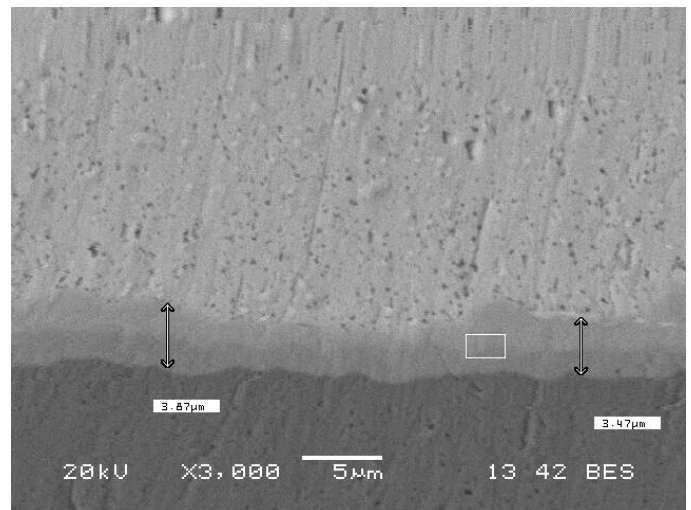
**Figure 7:** A representative view of part# 2 with Pb-free termination finish along board interface following thermal aging.

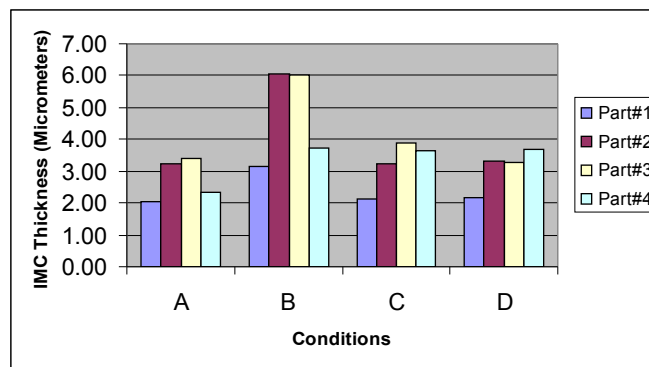
Figure 8: Graphical illustration of Table 5

The average IMC thickness across the component interface and board interface is shown in Table 3 and graphically plotted in Figure 8. The four columns in Table 3 represent the following:

IMC layer at the component/solder interface was slightly wider than at the board side for both as-assembled and thermally aged conditions. Additionally, the growth rate of IMC with thermal aging at the component interface was higher than at board interface for all the component types. Pb-free components had a thicker IMC layer

compared to Sn-Pb components. The growth rate of IMC along the component/solder interface due to thermal aging for converted Pb-free components (Part#2, 3) was higher than that of the original component (Part#4).

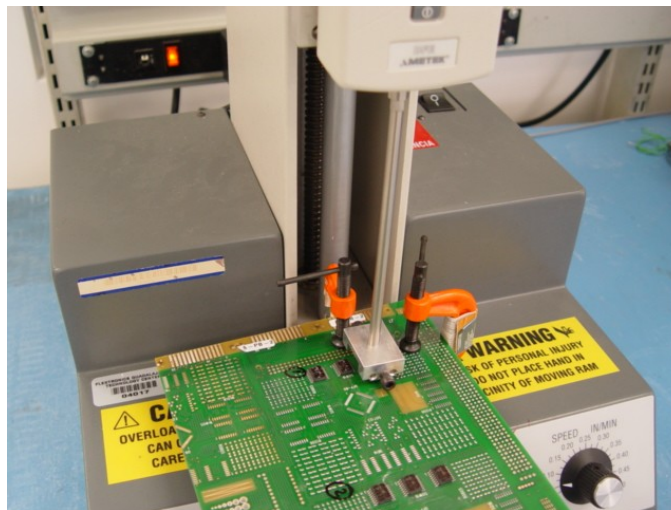
Figure 9: Setup for Pull Testing

Lead pull testing was conducted to investigate the pull strength of leads and evaluate the mechanical reliability of the original and converted components. It is a superior method compared to ball shear test, to identify failures of weak interfaces [4]. The testing was performed on a Chatillon TCM 201-SS, DFE-100 equipment. Testing was performed with the following parameters: test speed 0.3 inch/minute and maximum test load of 50 Kgf.

Figure 9 illustrates the setup of the pull tester used in this study. Pull testing was performed on the SOIC 7.6 mm pitch components (Part#5, 6, 7, 8, 9).

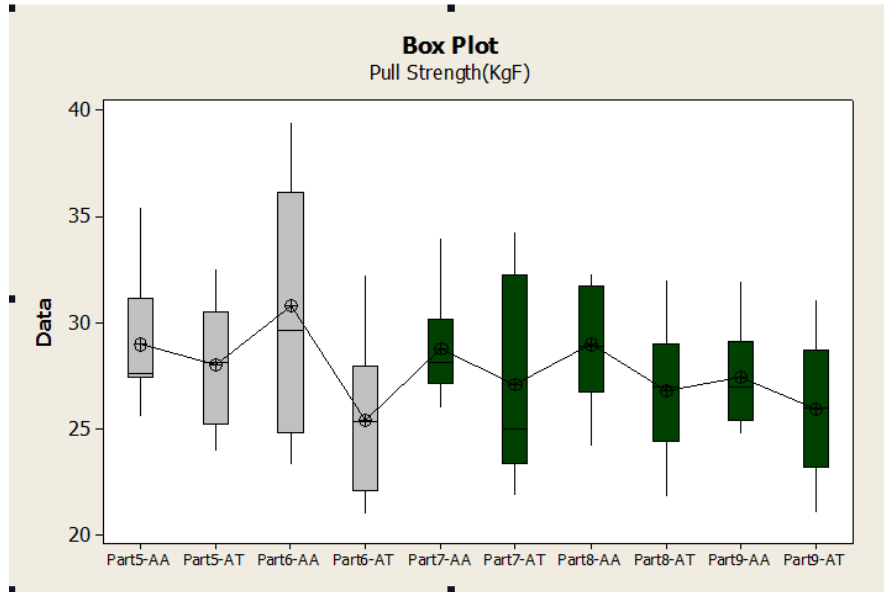
Figure 10 is a box plot based on the pull test results for Part#5, 6, 7, 8, 9. For all part numbers, the mean pull strength decreased after thermal aging. This was expected as aging increases the thickness of IMC and makes the solder joints brittle.

The highest mean pull strength was recorded for Part#6 (Converted from 100% Sn to SnPb) at “As-Assembled (AA)” condition while the lowest mean pull strength was also recorded on part#6 at “After Thermal Aging (ATA)” condition. Sn-Pb components had slightly higher mean pull strengths than Pb-free components before and after conversion. A statistical t-test was conducted using MINITAB to determine if there is any significant difference between the different part types. Only part #6 showed a significant decrease in the mean pull strength after thermal aging.

The pull strength of the part converted from SnPb to SAC305 component (Part #7) was almost same to that of the part before conversion (Part #5), at both AA and ATA conditions. There was not much significant difference between pull strengths of original 100% matte tin component (Part#9) and after it was converted to SAC305 finish (Part#8), at both AA and ATA conditions. However, the pull strength increased significantly at AA condition, when original 100% matte tin component (Part#9) was converted to SnPb finish (Part# 6). In contrast, the pull strength decreased significantly at ATA condition, when original 100% matte tin component ( Part#9) was converted to SnPb finish (Part#6), as shown in Figure 10. All these data indicate that mechanical strength was not considerably affected during the conversion process.

Figure 10: A box plot comparing mean pull strengths of all part numbers. Parts with SnPb termination finish is shown in grey, while parts with lead-free finish are shown in green.

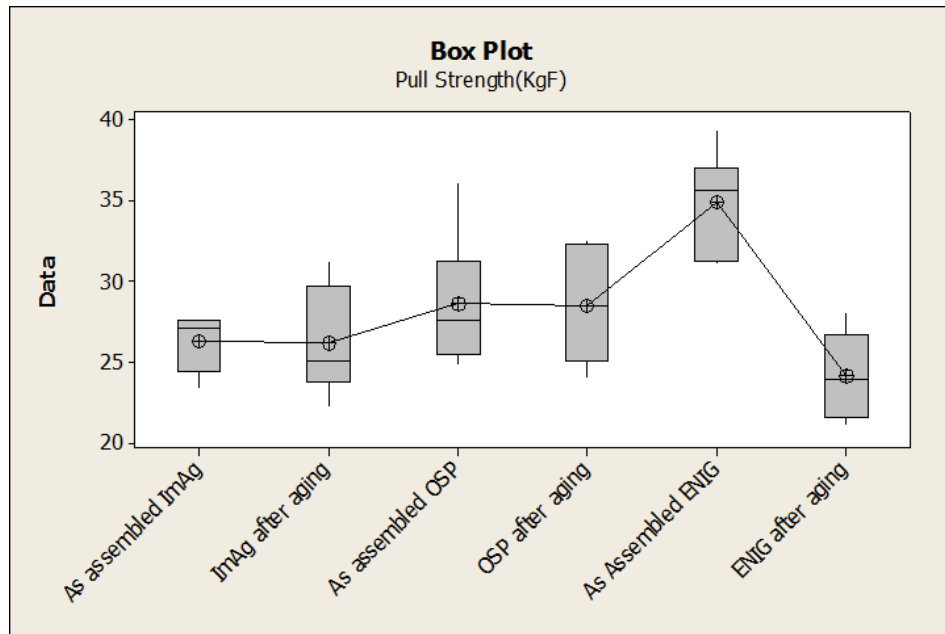
Figure 11 is a box plot showing pull testing results for SnPb component finish with three different PCB surface finishes, namely, ImAg, OSP and ENIG. Among all PCB surface finishes ENIG has the highest mean pull strength before aging, however, after aging, ENIG has the lowest mean pull strength. After conducting a t-test, the statistical analysis showed that the mean pull strength of ENIG did decrease significantly after thermal aging, while aging did not significantly affect the mean pull strength for ImAg and OSP PCB surface finishes. A similar trend was also observed for lead-free parts, as shown in Figure 12.

Figure 11: A box plot showing mean pull strengths for SnPb parts with ImAg, OSP and ENIG PCB surface finishes at AA and ATA conditions.

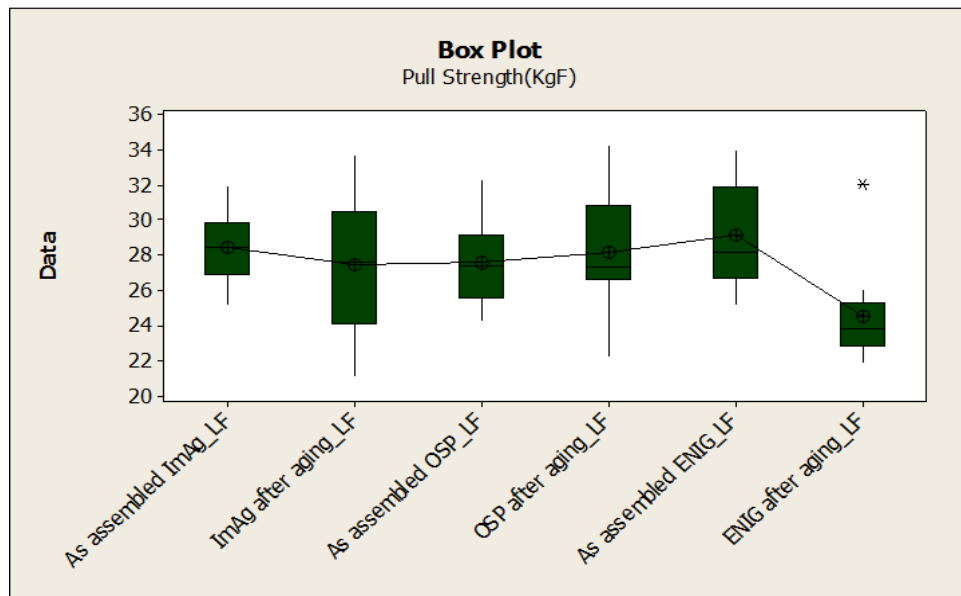
Figure 12: A box plot showing mean pull strengths for lead-free parts with ImAg, OSP and ENIG PCB surface finishes at AA and ATA conditions.

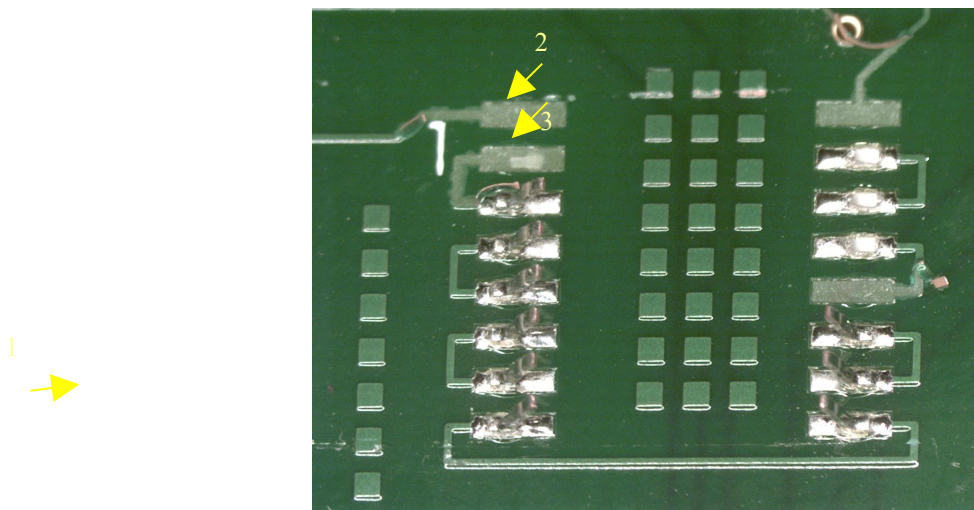
Figure 13 shows the three types of failure modes observed during the pull testing. At as-assembled condition, the percentage of failures due to broken leads, lifted pads, and lifted leads were 43%, 29%, and 28%, respectively. This implies that the weakest link of the solder joint at ‘as-assembled’ condition is within the bulk of the solder joint which is a normal characteristic of a good interconnection. After thermal aging, the percentages of failures due to broken leads, lifted pads, and lifted leads were 22%, 16%, and 62% respectively, which implies that the weakest link of the solder joint is at the interface between the component lead and the PCB. The reason for this weak interface is due to aging which increases the IMC thickness, making the interface layer brittle and weak.

Figure 13. A representative view from a component after pull test, showing different failure modes: (i). Broken leads, (ii). Lifted pad and (iii). Lifted lead
